New Hampshire Volunteer Lake Assessment Program

2002 Bi-Annual Report for Seavey Pond Windham

Seavey Pond, Windham

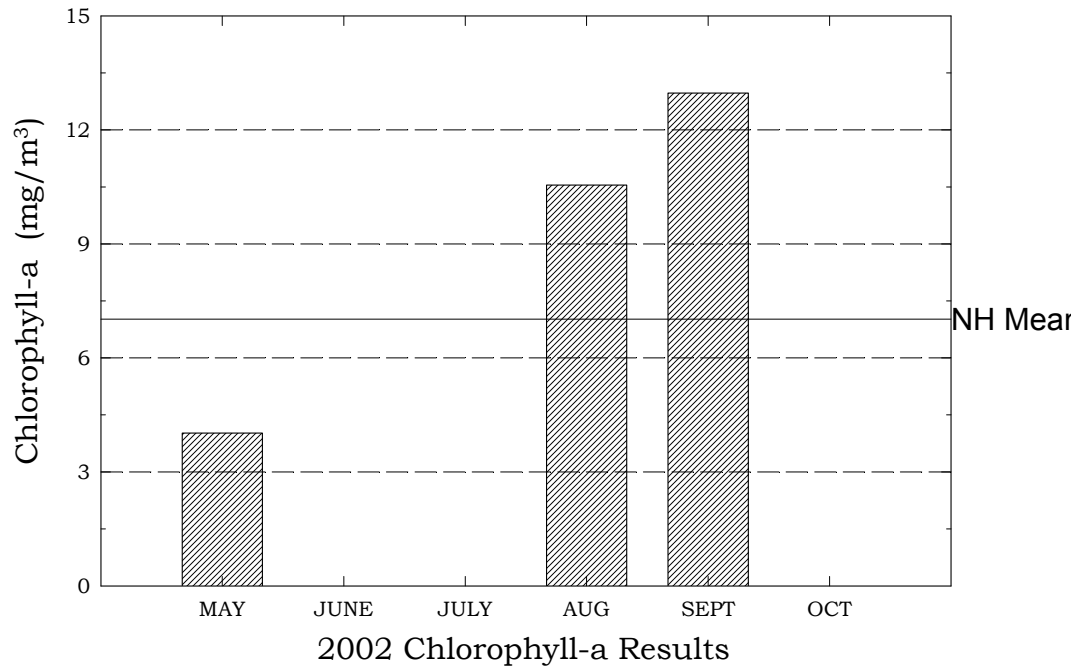
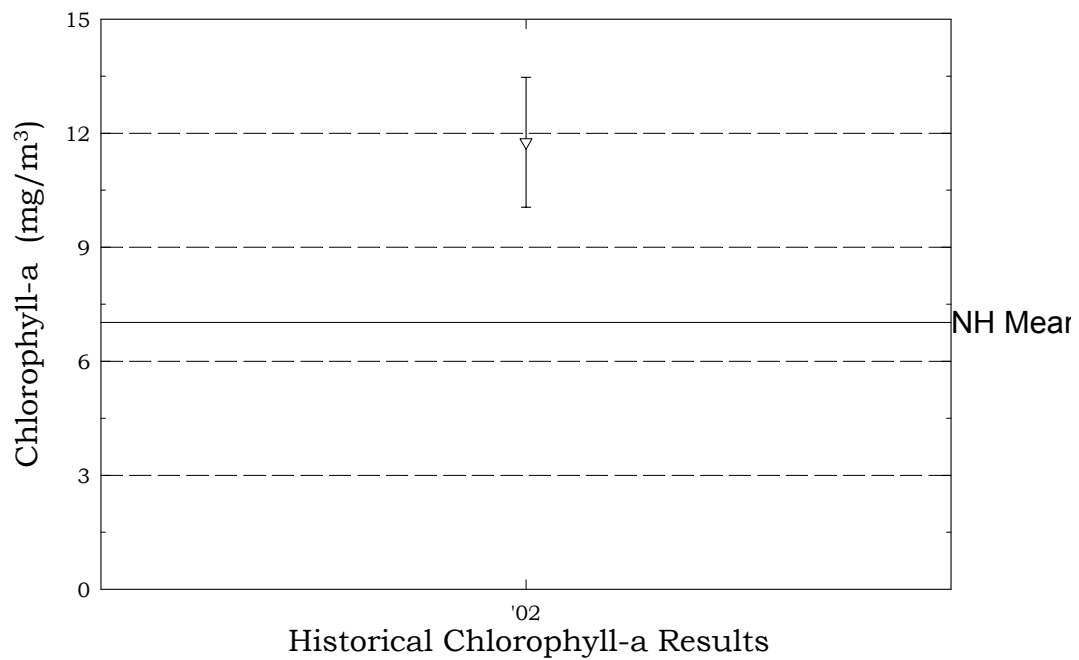
Figure 1. Monthly and Historical Chlorophyll-a Results

- **Figure 1 and Table 1:** The graphs in Figure 1 (Appendix A) show the historical and current year chlorophyll-a concentration in the water column. Table 1 (Appendix B) lists the maximum, minimum, and mean concentration for each sampling season that the lake/pond has been monitored through the program.

The current year data (the top graph) show that the chlorophyll-a concentration **increased by a large amount** from May to August, and then continued to **increase** from August to September.

The historical data (the bottom graph) show that the 2002 chlorophyll-a mean is ***much greater than*** the state mean.

While algae are naturally present in all lakes/ponds, an excessive or increasing amount of any type is not welcomed. In freshwater lakes/ponds, phosphorus is the nutrient that algae depend upon for growth. Therefore, algal concentrations may increase when there is an increase in nonpoint sources of nutrient loading from the watershed, or in-lake sources of phosphorus loading (such as phosphorus releases from the sediments). It is important to continually educate residents about how activities within the watershed can affect phosphorus loading and lake quality.

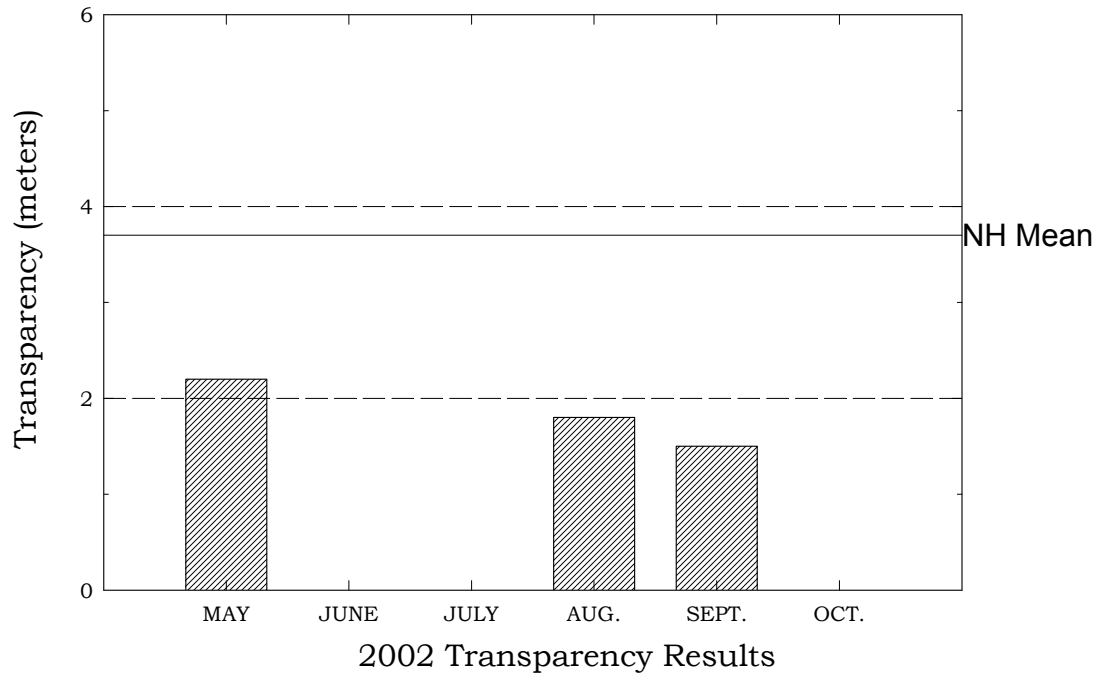
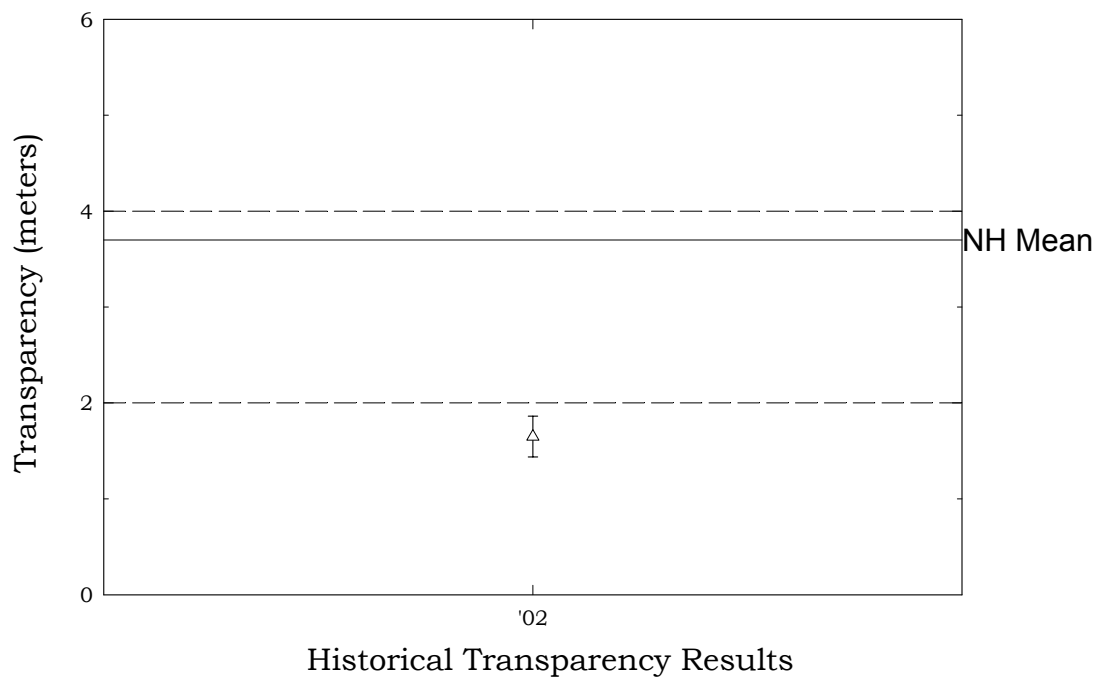
Figure 2. Monthly and Historical Transparency Results

- **Figure 2 and Table 3:** The graphs in Figure 2 (Appendix A) show historical and current year data for lake/pond transparency. Table 3 lists the maximum, minimum and mean transparency data for each sampling season that the lake/pond has been monitored through the program.

The current year data (the top graph) show that the in-lake transparency **decreased** from May to August, and then **continued to decrease** from August to September.

It is important to note that as the chlorophyll-a concentration increased from May to September this season, the transparency decreased. We typically expect this inverse relationship in lakes. As the amount of algal cells in the water increases, the depth to which one can see into the water typically decreases.

Typically, high intensity rainfall causes erosion of sediments into lakes/ponds and streams, thus decreasing clarity. Efforts should continually be made to stabilize stream banks, lake/pond shorelines, disturbed soils within the watershed, and especially dirt roads located immediately adjacent to the edge of tributaries and the lake/pond. Guides to Best Management Practices designed to reduce, and possibly even eliminate, nonpoint source pollutants, such as sediment loading, are available from NHDES upon request.

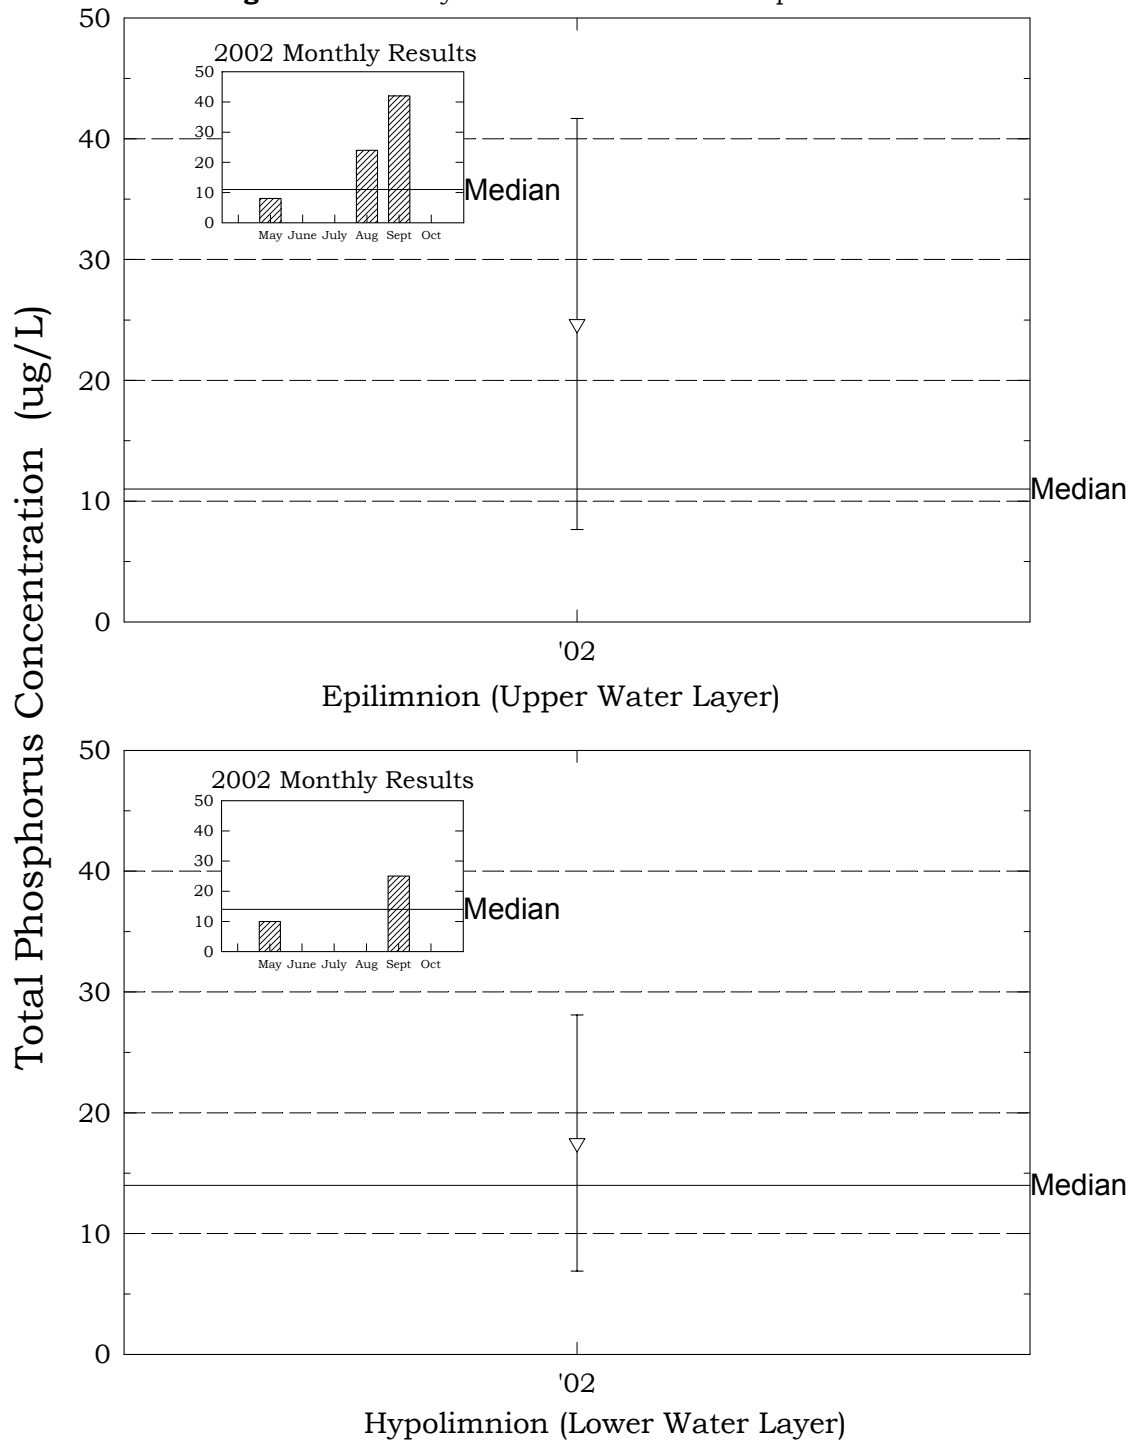
Figure 3. Monthly and Historical Total Phosphorus Data.

- **Figure 3 and Table 8:** The graphs in Figure 3 (Appendix A) show the amounts of phosphorus in the epilimnion (the upper layer) and the hypolimnion (the lower layer); the inset graphs show current year data. Table 8 (Appendix B) lists the annual maximum, minimum, and median concentration for each deep spot layer and each tributary since the lake/pond has joined the program.

The current year data for the epilimnion (the top inset graph) and the hypolimnion (the lower inset graph) show that the total phosphorus concentration **increased** from May to September.

The historical data show that the 2002 mean epilimnetic total phosphorus concentration is **greater than** the state median.

The historical data show that the 2002 mean hypolimnetic total phosphorus concentration is **slightly greater than** the state median.

One of the most important approaches to reducing phosphorus loading to a waterbody is to continually educate watershed residents about its sources and how excessive amounts can adversely impact the ecology and value of lakes and ponds. Phosphorus sources within a lake or pond's watershed typically include septic systems, animal waste, lawn fertilizer, road and construction erosion, and natural wetlands. If you would like to educate watershed residents about how they can help to reduce phosphorus loading into the lake/pond, please contact the VLAP Coordinator.
